NACA RM E55K22

EFFECTS OF ROCKET-ARMAMENT EXHAUST GAS ON THE

PERFORMANCE OF A SUPERSONIC -INLET

J34-TURBOJET -ENGINE INSTALLATION

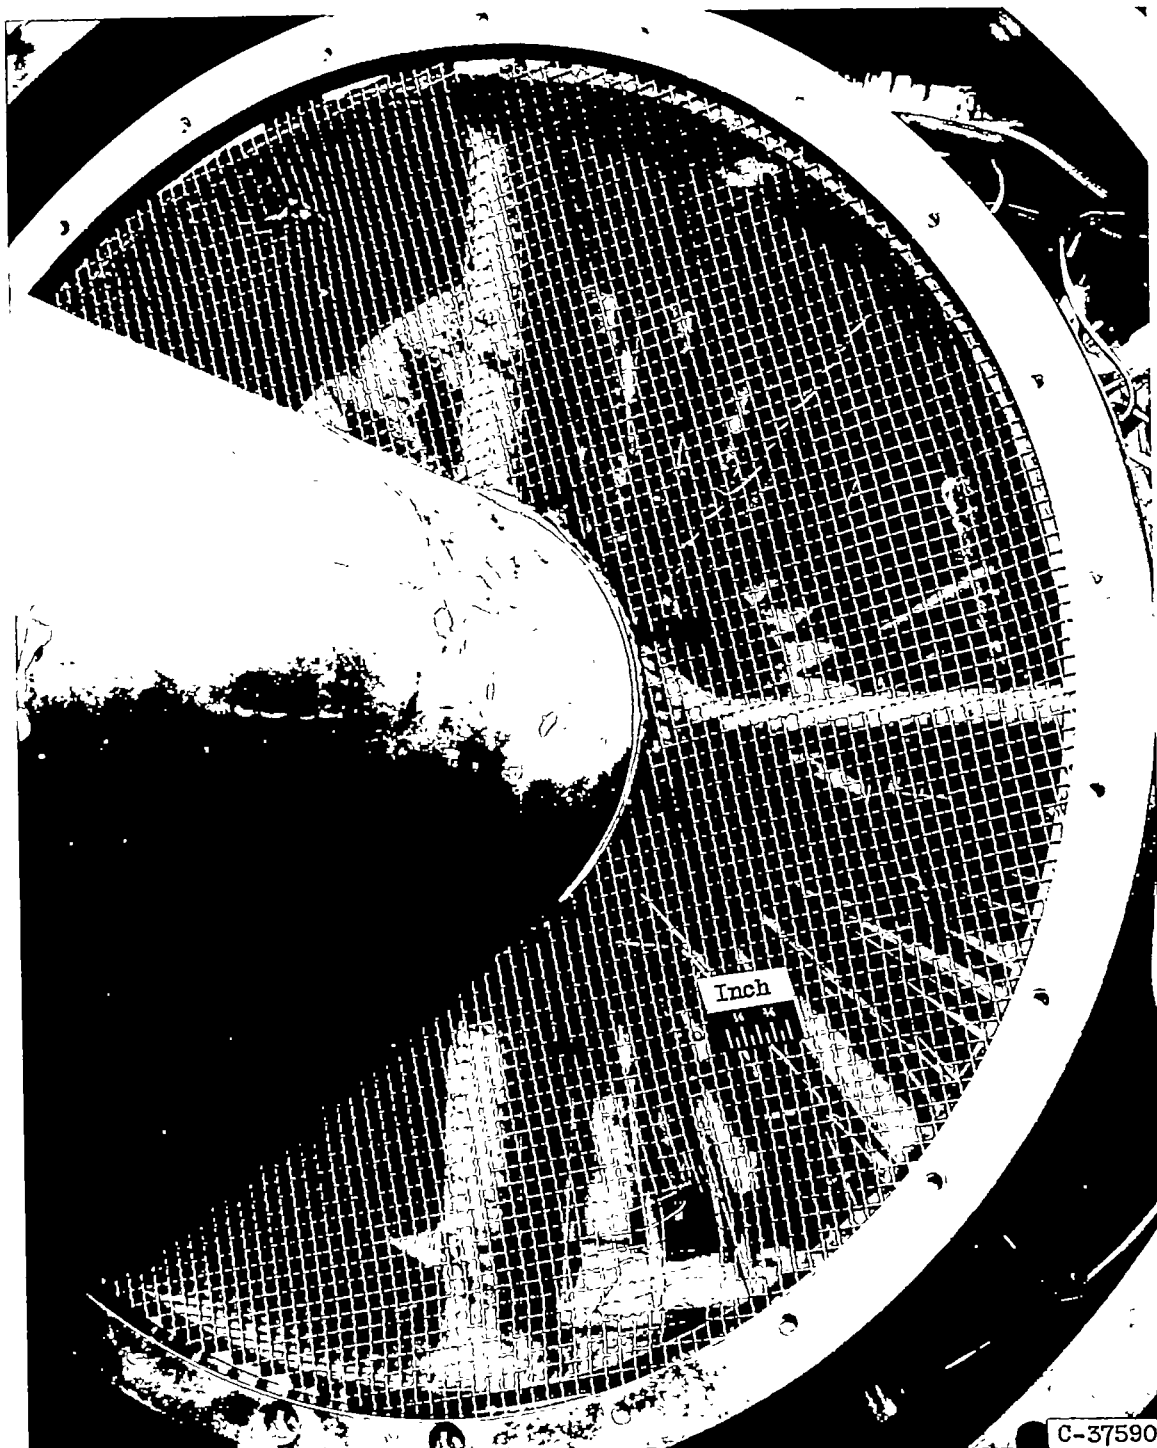
Debris resulting from the multirocket burning entered the inlet and caused some damage. A photograph of the protective screen installed ahead of the compressor is shown in figure 8. A large hole was torn in the screen at the bottom, and some of the compressor blades were nicked. This damage may have resulted from impact with pieces of unburnt propellant, the firing wire, or perhaps pieces of the plastic liner in the rocket. Several pieces of this plastic can be seen on the screen in

the photograph. There is also an indentation in the upper left-hand corner of the screen caused by a piece of plastic. As stated earlier, the metal caps in the rocket nozzle were removed beforehand. Presumably these metal caps and the firing wire would remain in the launcher in an airplane installation and would not cause difficulty.

3. Flame-out did not occur, nor were there any positive indications of compressor stall.
4. Debris resulting from the rocket burning entered the inlet and damaged a compressor protective screening and slightly dented some compressor blades.

Figure 8. - Damage to compressor-inlet screen after firing of rockets 2, 3, and 4.
